Moisture-Induced Delamination Video of an Oxidized Thermal Barrier Coating

James L. Smialek, Dongming Zhu, and Michael D. Cuy
NASA Glenn Research Center, Cleveland, OH 44135

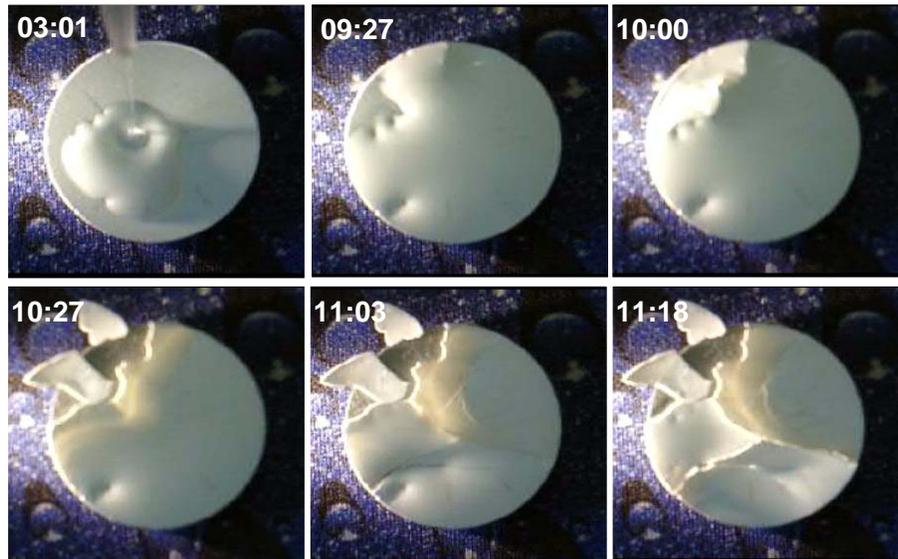
The TBC was seen to be intact after 100 hours, with essentially no distinguishing features, despite additional handling for photography. Similarly, the start of the 30 second video presented in the auxiliary e-file (figure A1) shows an intact TBC of the same sample after cooldown from 300 hours. A few water drops were applied from a wash bottle and appeared as a thick convex meniscus. Soon afterwards, the rapid production of catastrophic delamination cracks became apparent, until finally the entire coating had failed, as summarized by the still frames in figure 2. The time from the first application of water until a specific crack was formed is labeled on the final still photo of figure 3. Here about 6 seconds elapsed before the first crack appeared, and approximately 3 more seconds were required to fail the entire surface. These time intervals refer primarily to the incubation of a crack rather than propagation. The actual crack velocity was much faster, as viewed in real time.

Figure 2. Still frames from video sequence listing start times of water application and complete delamination in 9 seconds. (EB-PVD TBC, pre-oxidized 300 hr at 1150°C).

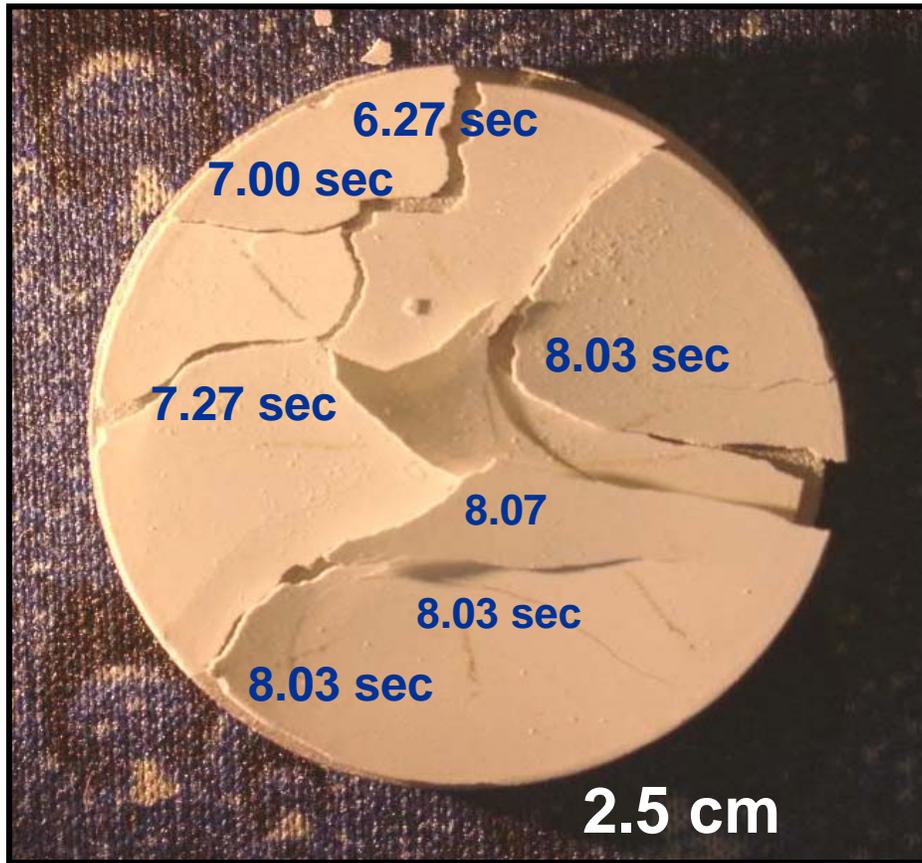
Figure 3. Final appearance of failed TBC after water drop experiment; incubation times for specific cracks range from 6-8 seconds.

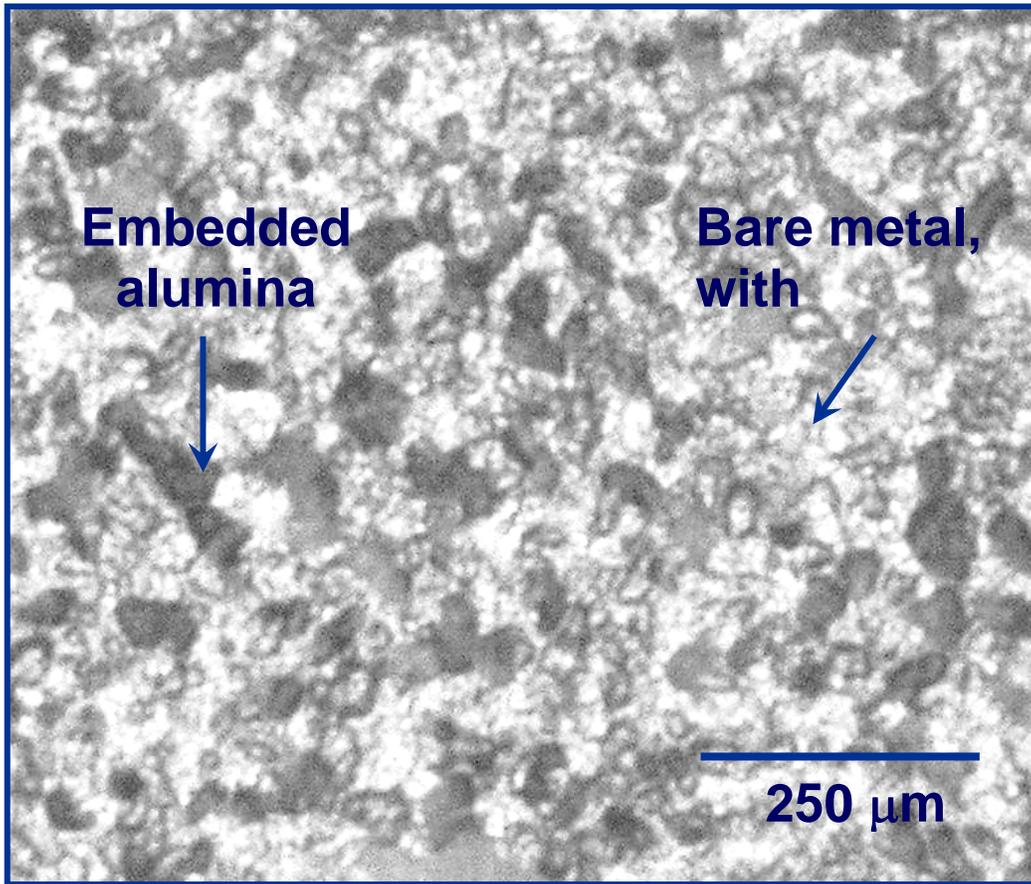
Preliminary observation via optical microscopy revealed very little retained TBC material, islands of alumina scale embedded into the bond coat, and a continuous sea of bare metal. The latter featured the tell-tale interfacial imprints of the previously adjacent alumina grains and a fair degree of surface undulation. Some of these features can be discerned in the low magnification macrograph of figure 4.

Figure 4. Macrograph of exposed bond coat metal after TBC failure, indicating Al_2O_3 spallation to bare metal and trapped Al_2O_3 oxide intrusions.
